DELAWARE RIVER BASIN

Beechwood
COLONIAL LAKE DAM

PHASE I INSPECTION REPORT
NATIONAL DAM SAFETY PROGRAM

NJ 00261

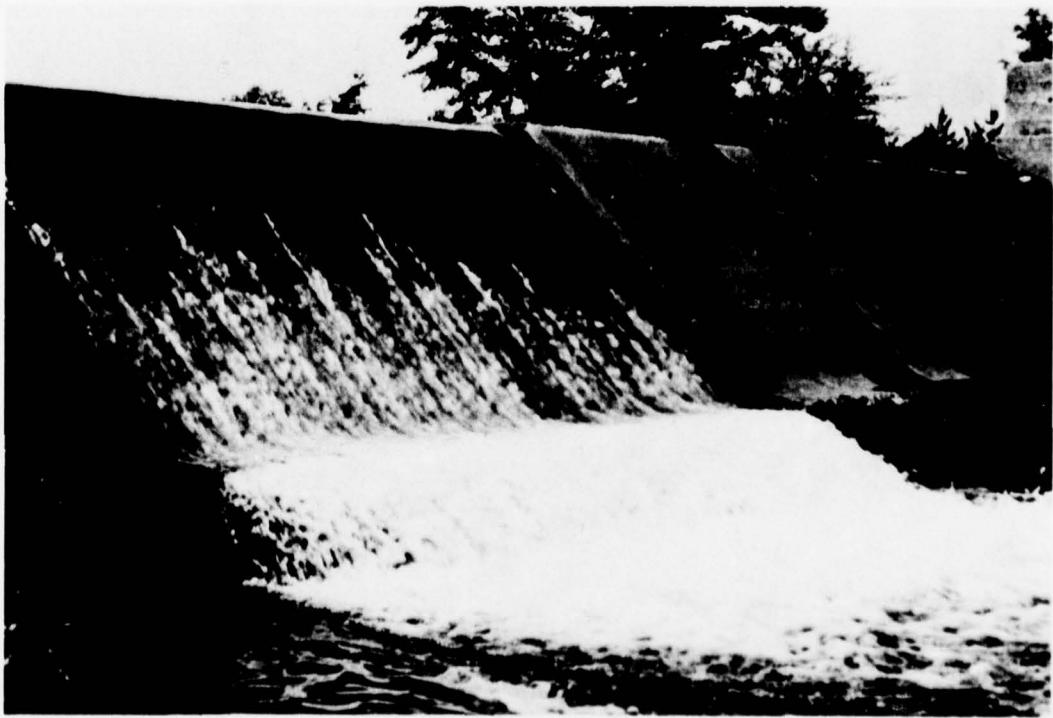
PHOTO 2

Photo 2 - Main Spillway With Water Flowing Through Low Flow Notch - 22 June 1978

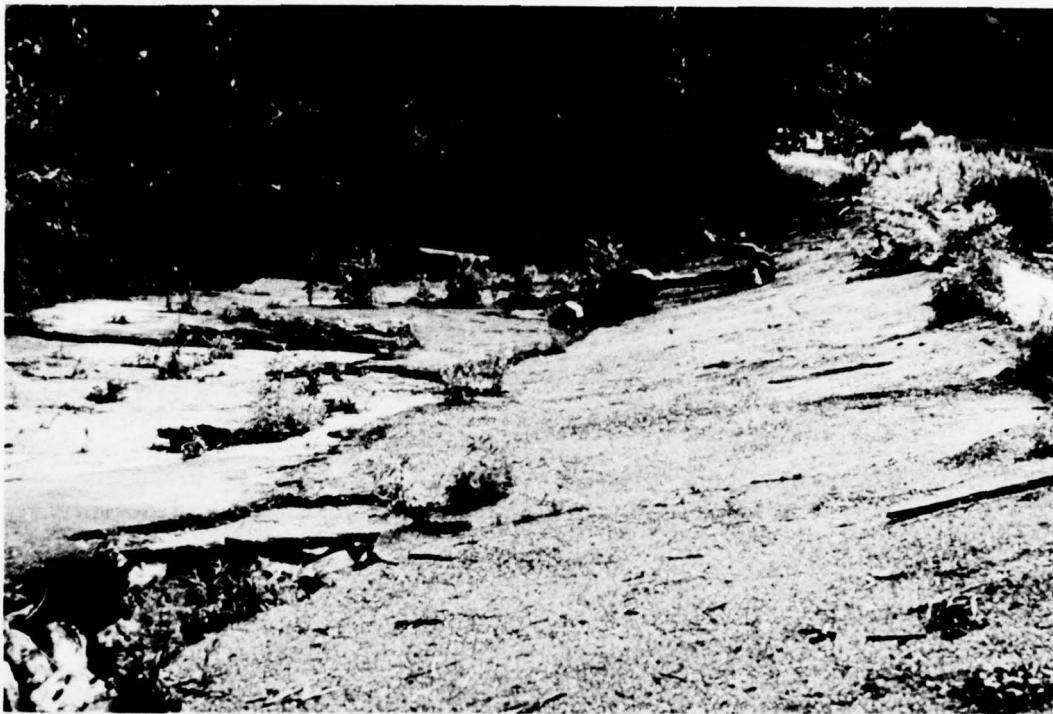
PHOTO 5

Photo 5 - Flood Flow (Auxiliary) Spillway Paved with Asphalt Over Concrete (Note Eroded and Collapsed Area in Foreground. A Timber Core Wall Underlies the Crest of the Flood Flow Spillway as Shown on Plate 2.) - 22 June 1978

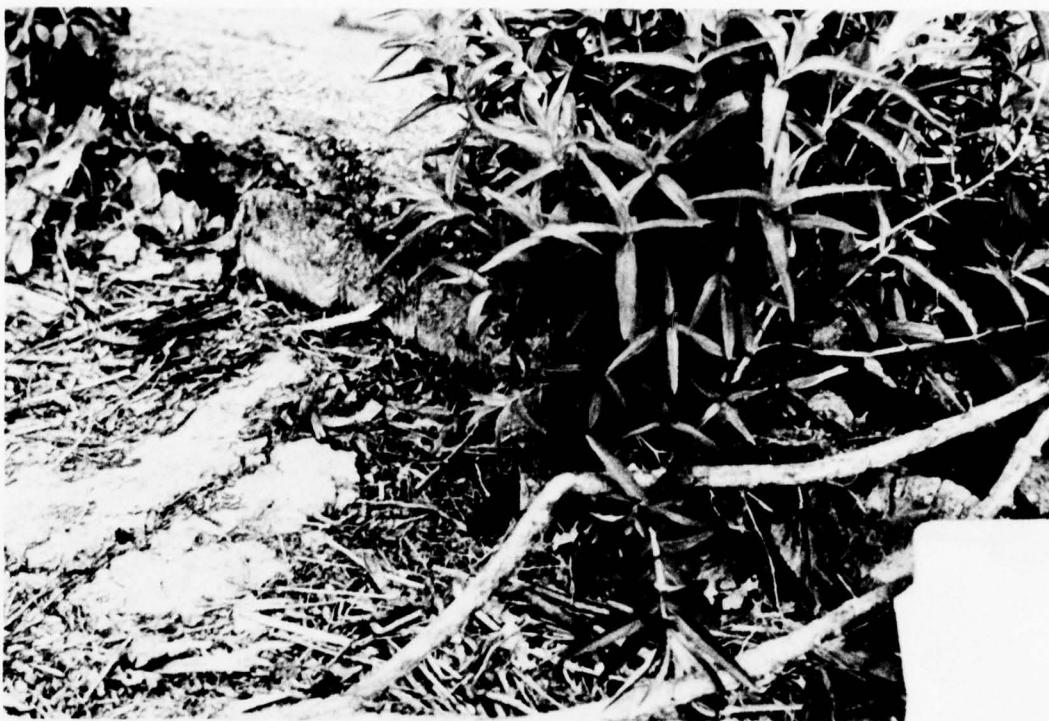
PHOTO 9

- 1) Reducing the freeboard to only approximately 1.07 feet, and increasing the frequency of dam overtopping and the chances of failure during floods.
- 2) Additional erosion of the embankment during flood flows at the location where the timber core wall is exposed may also result in failure of the dam.

Photo 9 - Timber Core Wall Exposed Where Asphalt Paving of Flood Flow Spillway Has Washed Away - 22 June 1978

- 2) Since construction of the new dam will require time, it is recommended that the owner immediately backfill the eroded holes in the embankment which expose the timber core wall, and the eroded holes and washed out toe of the paved flood flow spillway section. The method of placement and type of material used to backfill the eroded holes should be engineered.

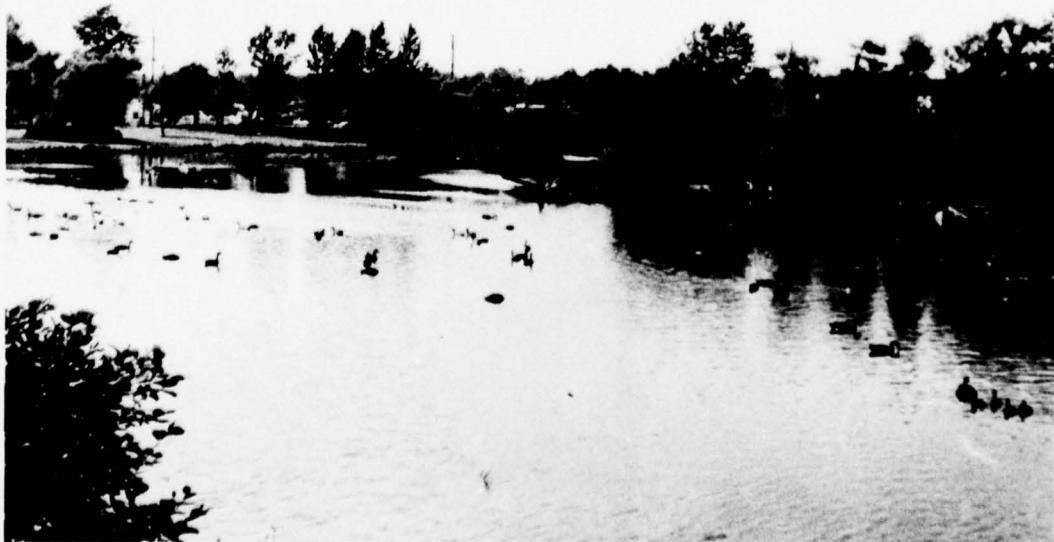
PHOTO 10

- c. Reservoir Area - The heavy siltation of the lake detracts seriously from its recreational and aesthetic value. The sediment also imposes undesirable lateral forces on the dam. However, extensive dredging of the reservoir should not be done because of the very poor condition of the dam, since this would cause additional significant downstream flows in the event of a failure.

Photo 10 - View of Upper End of Heavily Silted Colonial Lake (Note Debris Extending Above Water Level in Center of Picture.) - 22 June 1978
